**CONNECTICUT RIVER BASIN
WILLIAMSBURG, MASSACHUSETTS**

**MOUNTAIN STREET RESERVOIR DAM
MA 00082**

**MOUNTAIN STREET RESERVOIR DIKES
MA 01295**

**PHASE I INSPECTION REPORT
NATIONAL DAM INSPECTION PROGRAM**

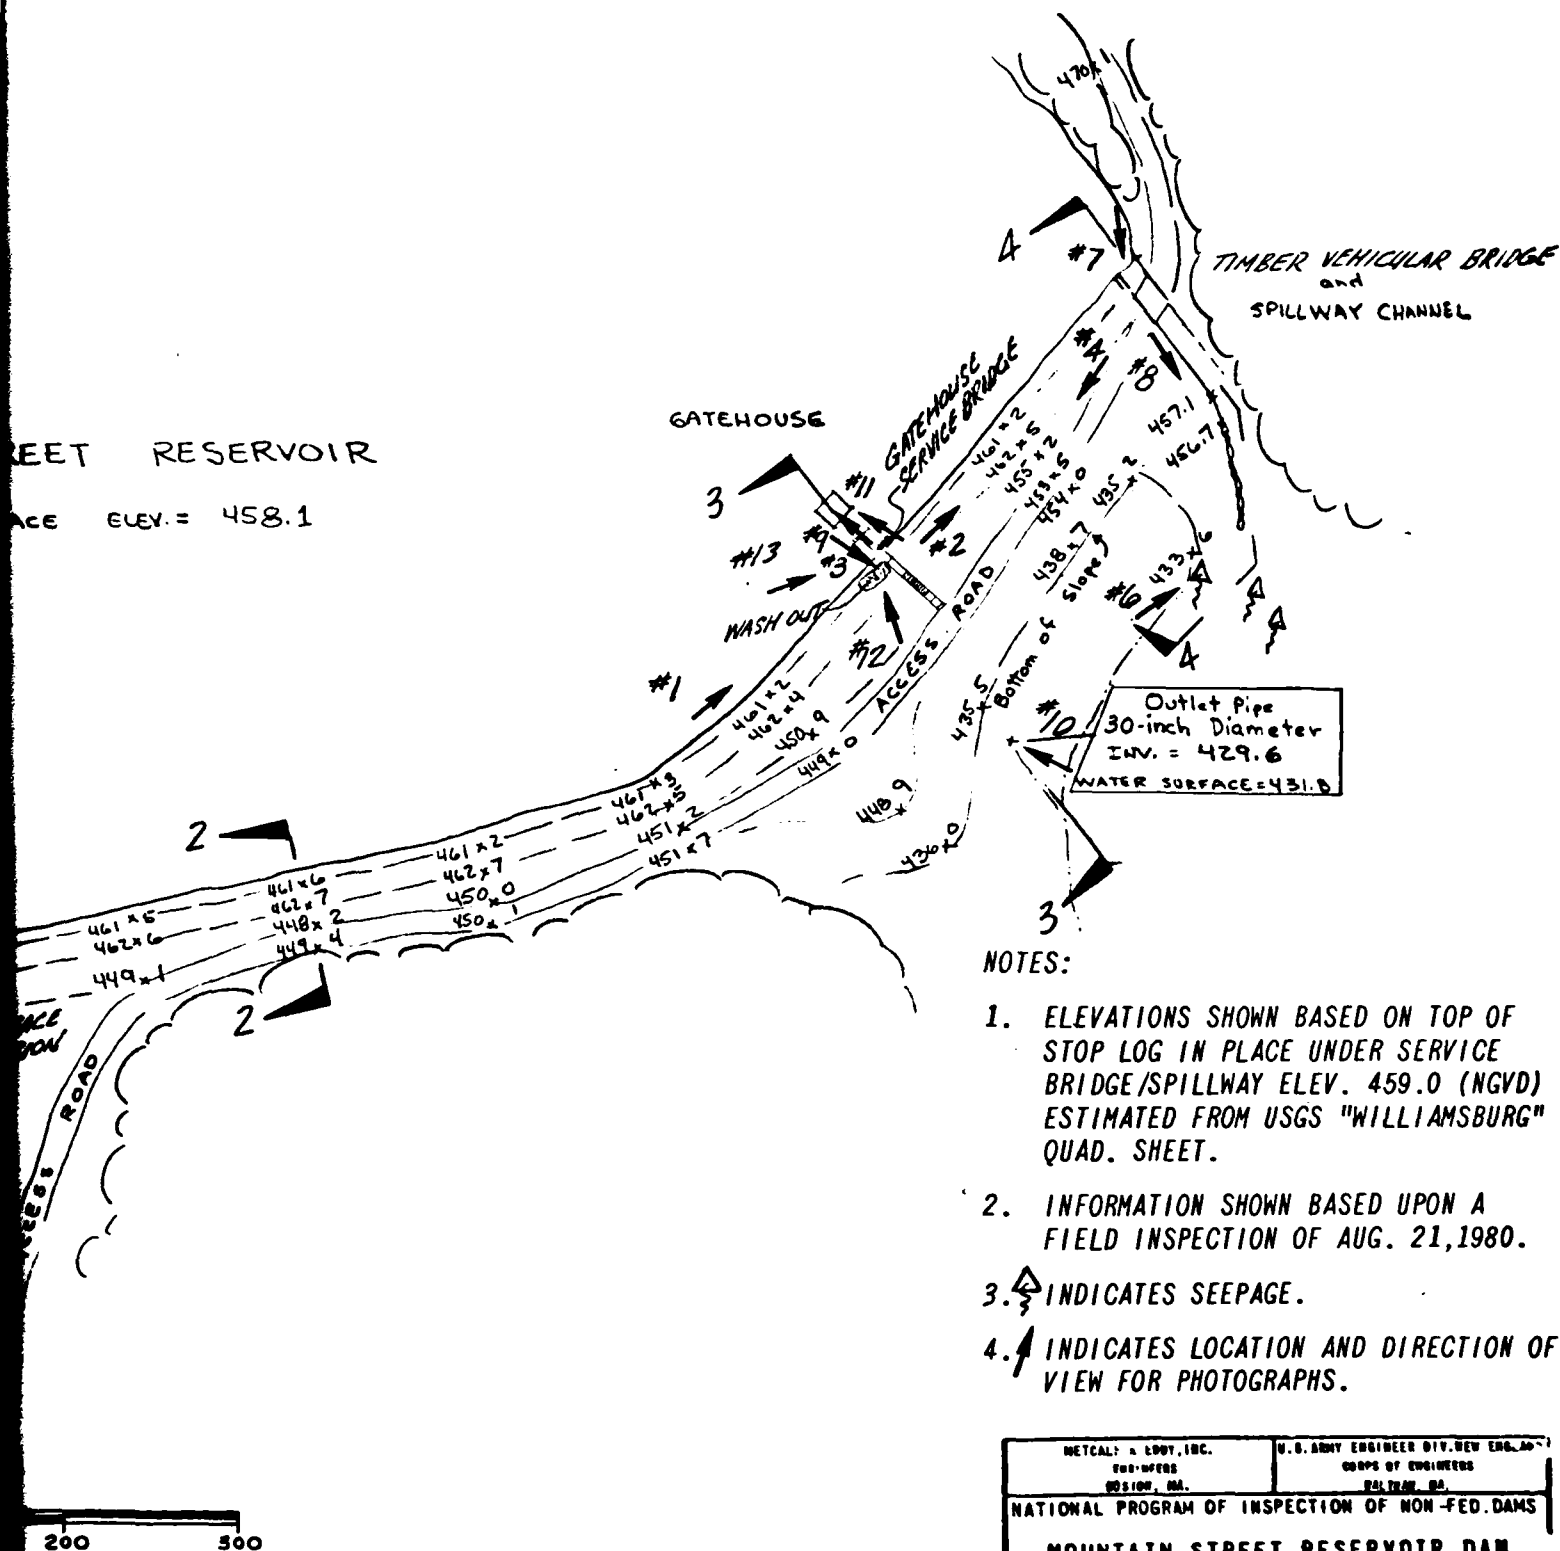
METCALE & EDDY, INC. ENGINEERS BOSTON, MA.	U.S. ARMY ENGINEER DIV. NEW ENG. DIST. CORPS OF ENGINEERS FALMOUTH, MA.
NATIONAL PROGRAM OF INSPECTION OF NON-FED. DAMS	
MOUNTAIN STREET RESERVOIR DAM	
FIGURE B-1 PLAN OF DAM	
TRIBUTARY CONNECTICUT RIVER	MASSACHUSETTS
SCALE: AS SHOWN	DATE: SEPTEMBER, 1980

1. ELEVATIONS SHOWN BASED ON TOP OF STOP LOG IN PLACE UNDER SERVICE BRIDGE/SPILLWAY ELEV. 459.0 (NGVD) ESTIMATED FROM USGS "WILLIAMSBURG" QUAD. SHEET.
2. INFORMATION SHOWN BASED UPON A FIELD INSPECTION OF AUG. 21, 1980.
3. INDICATES SEEPAGE.
4. INDICATES LOCATION AND DIRECTION OF VIEW FOR PHOTOGRAPHS.

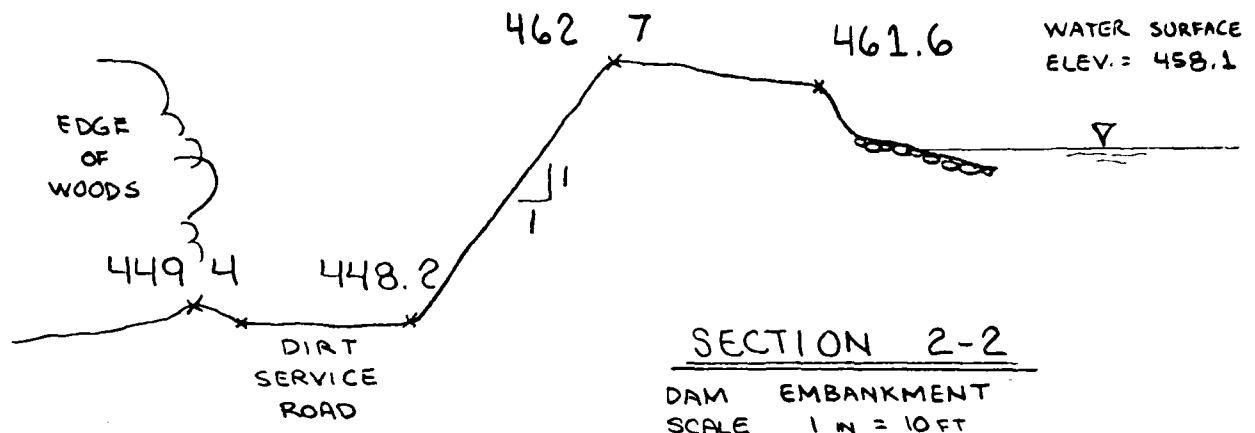
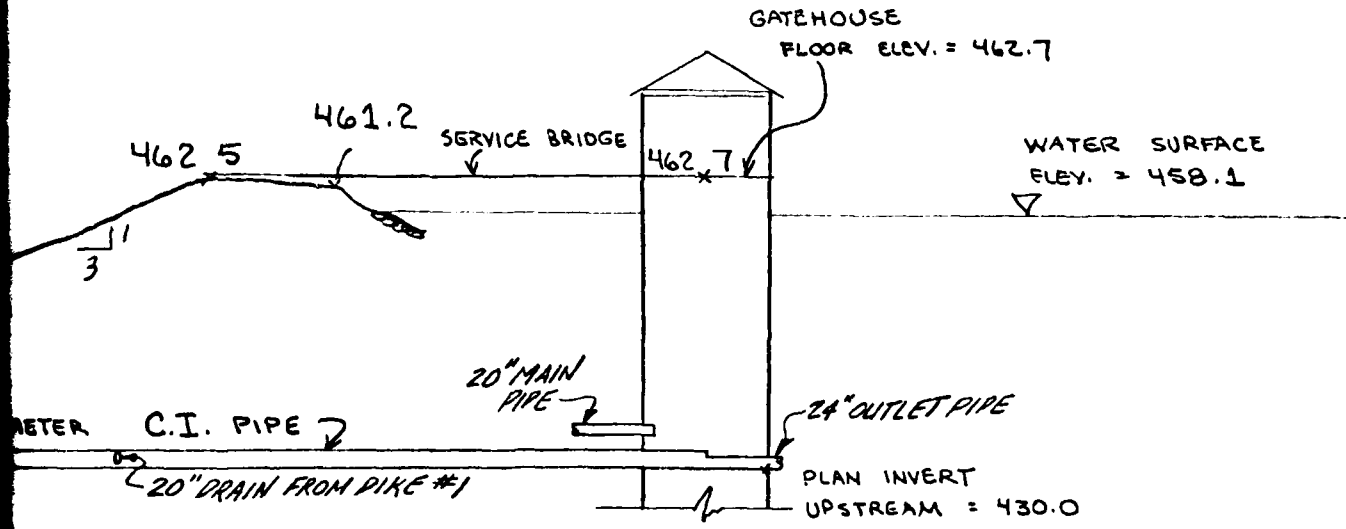
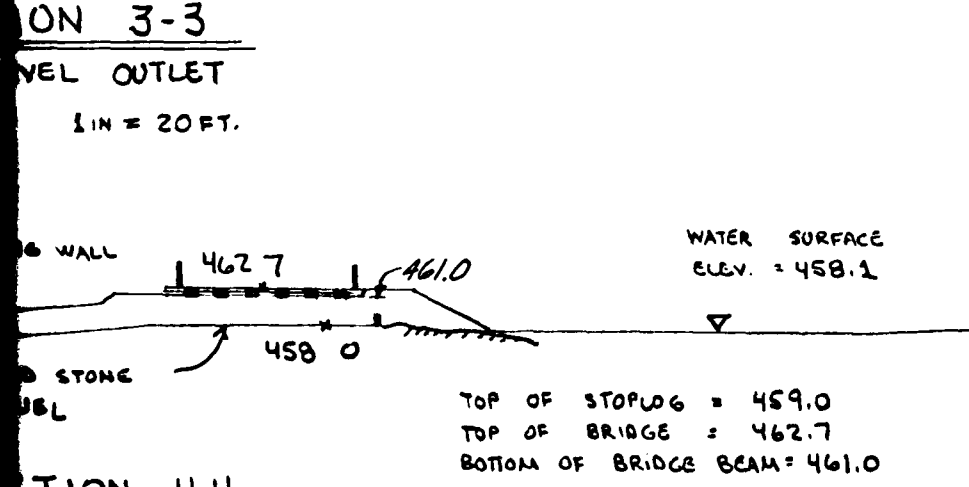
METCALF & EDDY, INC. ENGINEERS BOSTON, MA.	U.S. ARMY ENGINEER DIVISION CORPS OF ENGINEERS BOSTON, MA.
NATIONAL PROGRAM OF INSPECTION OF NON-FED. DAMS	
MOUNTAIN STREET RESERVOIR DAM	
FIGURE B-2 SECTIONS THROUGH DAM	
TRIBUTARY CONNECTICUT RIVER	MASSACHUSETTS
SCALE: AS SHOWN	DATE: SEPTEMBER, 1960

TOP OF STOPLOG = 459.0
TOP OF BRIDGE = 462.7
BOTTOM OF BRIDGE BEAM = 461.0
